**SURFACE-CHEMISTRY-DRIVEN TRIBOLOGICAL FUNDAMENTALS
OF DIAMOND AND SIC FOR EXTREME ENVIRONMENT
MEMS APPLICATIONS**

Final Report for the Period 01 August 2000 to 31 December 2000
AFOSR Contract No. FA9620-98-C-0009

Submitted by:
Engineering Services Center (ESC)
Sensors Engineering (SE)
Raytheon Electronic Systems (RES)
El Segundo, CA 90245

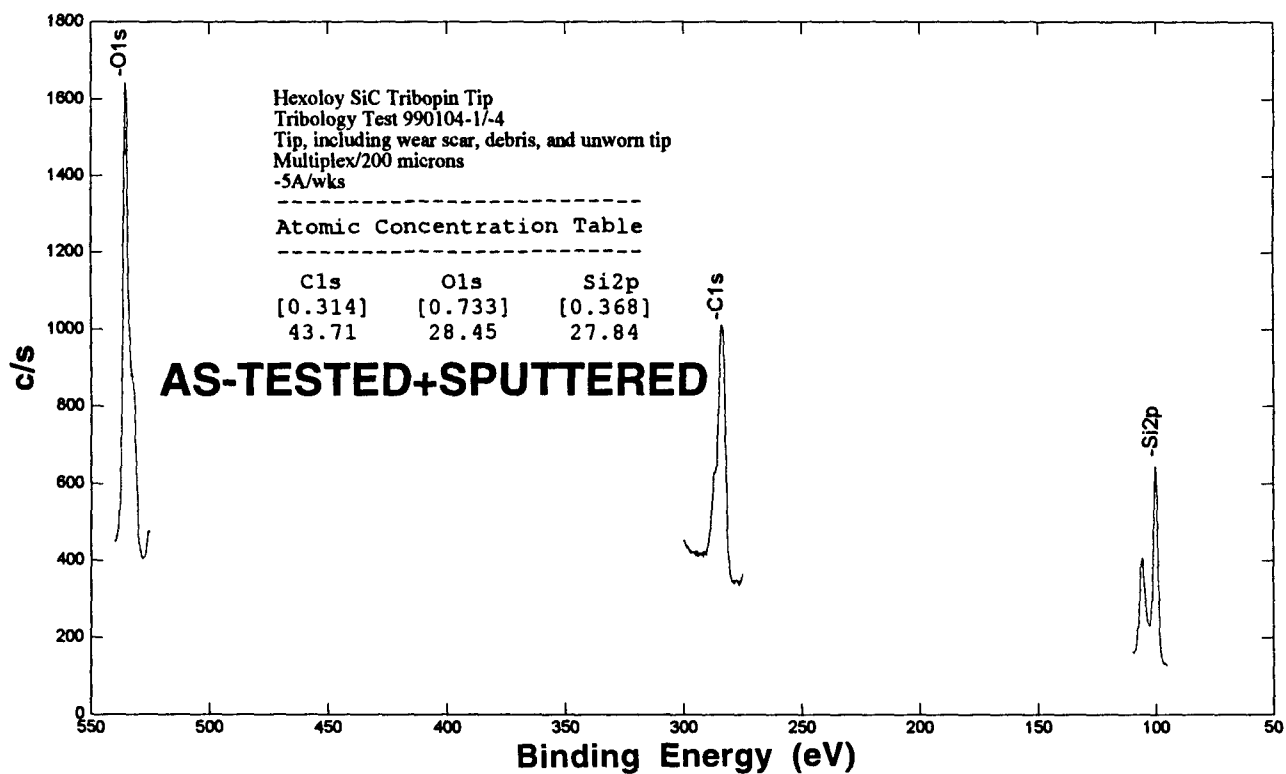
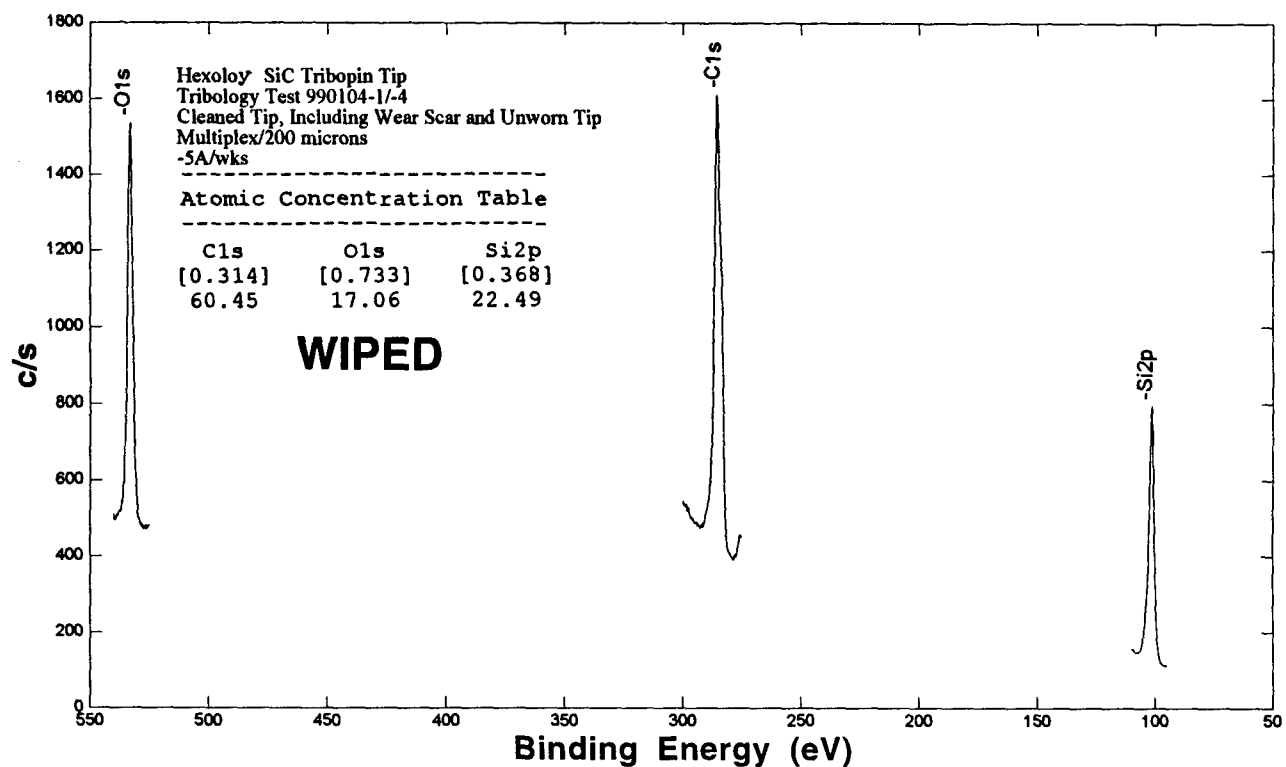
Figure 17. Multiplexed XPS spectra of the hexane+HF-washed and 3.4 Torr PO_2 -tested Hexoloy SiC pin tip wear scar, in the as-tested+Ar-sputtered (top) and wiped+Ar-sputtered (bottom) conditions; also see Table 4. Ar-sputtering removed 0.5 nm in each case.

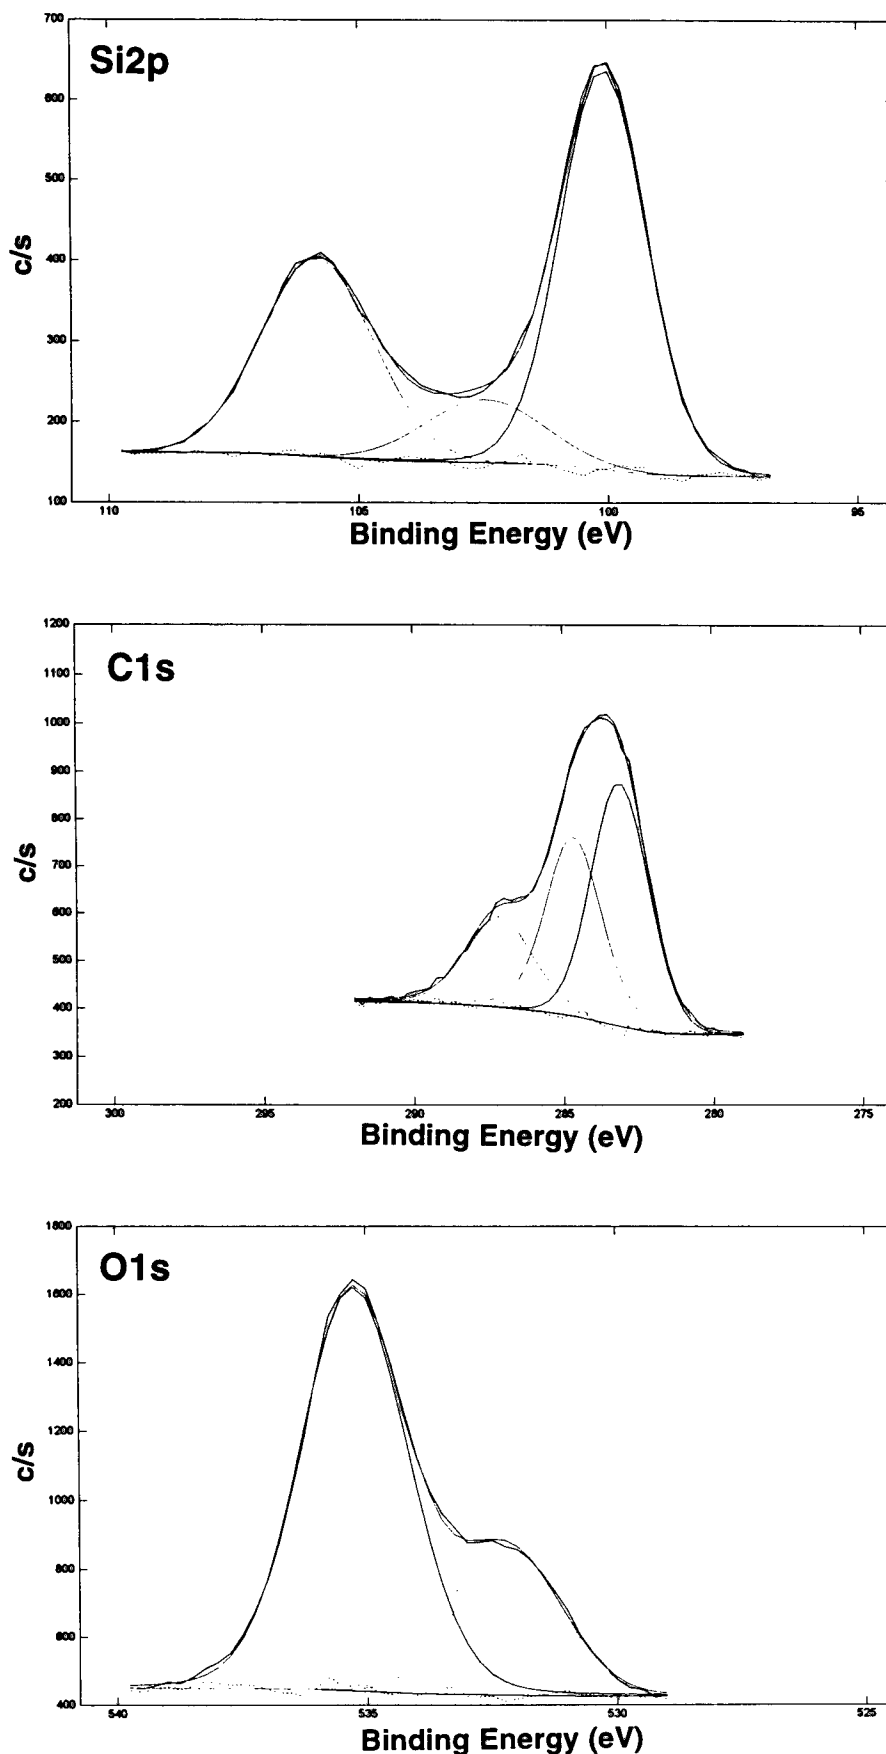
Figure 18. Deconvoluted Si, C and O spectral peaks of hexane+HF-washed and 3.4 Torr P_{O2}-tested Hexoloy SiC pin tip wear scar, in the wiped+Ar-sputtered condition (also see Table 4). Ar-sputtering removed 0.5 nm. Peak assignments: Si2p peaks: 100.0 eV = carbidic, 102.2 eV = Si-O, silicates, 105.8 eV = anomalously high value; C1s peaks: 282.7 eV = carbidic, 284.6 eV = graphitic, 286.7 eV = C-O, C=O; O1s peaks : 532.0 eV = O-Si, organic carbonyls, 535.2 eV = anomalously high value.

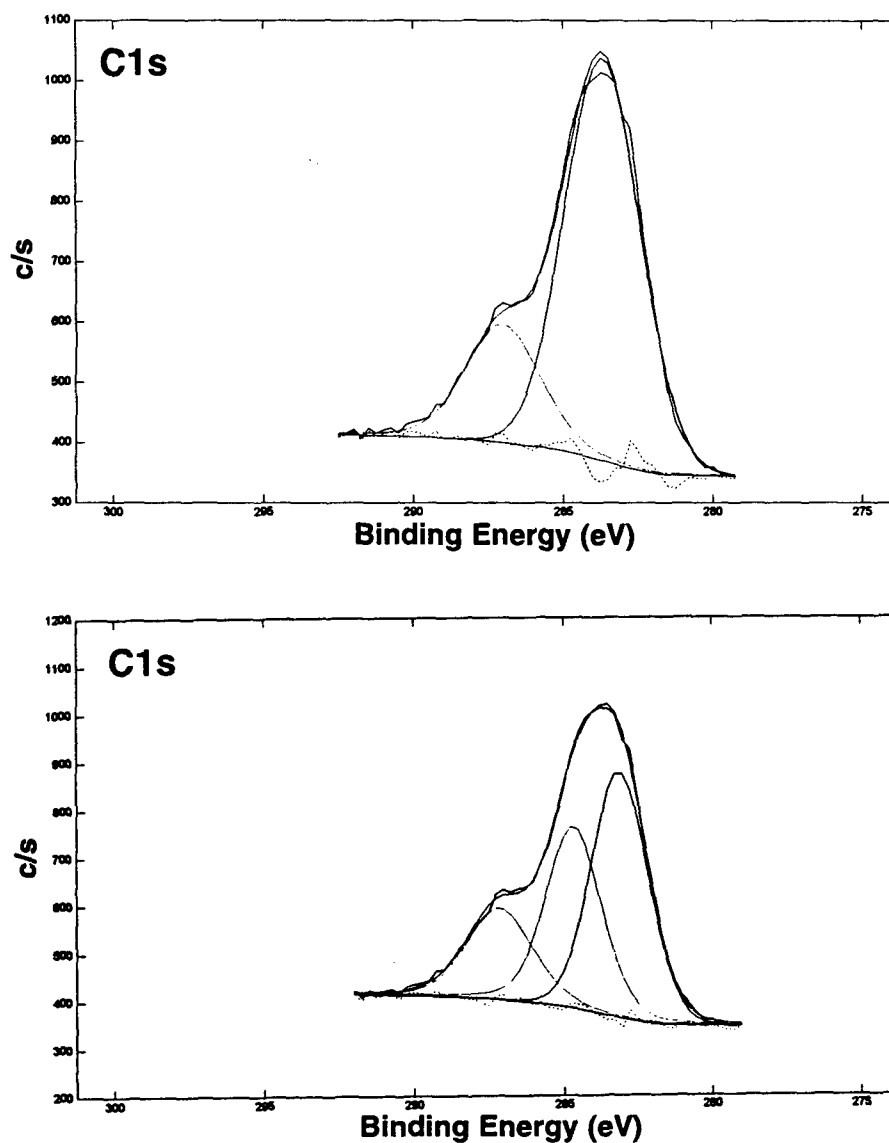
Figure 19. Improved deconvolution of the C1s spectral peak of hexane+HF-washed and 3.4 Torr PO₂-tested Hexoloy SiC pin tip wear scar, in the as-tested+Ar-sputtered condition. Ar-sputtering removed 0.5 nm. The dotted error function is significantly smoothed by incorporating the third peak.

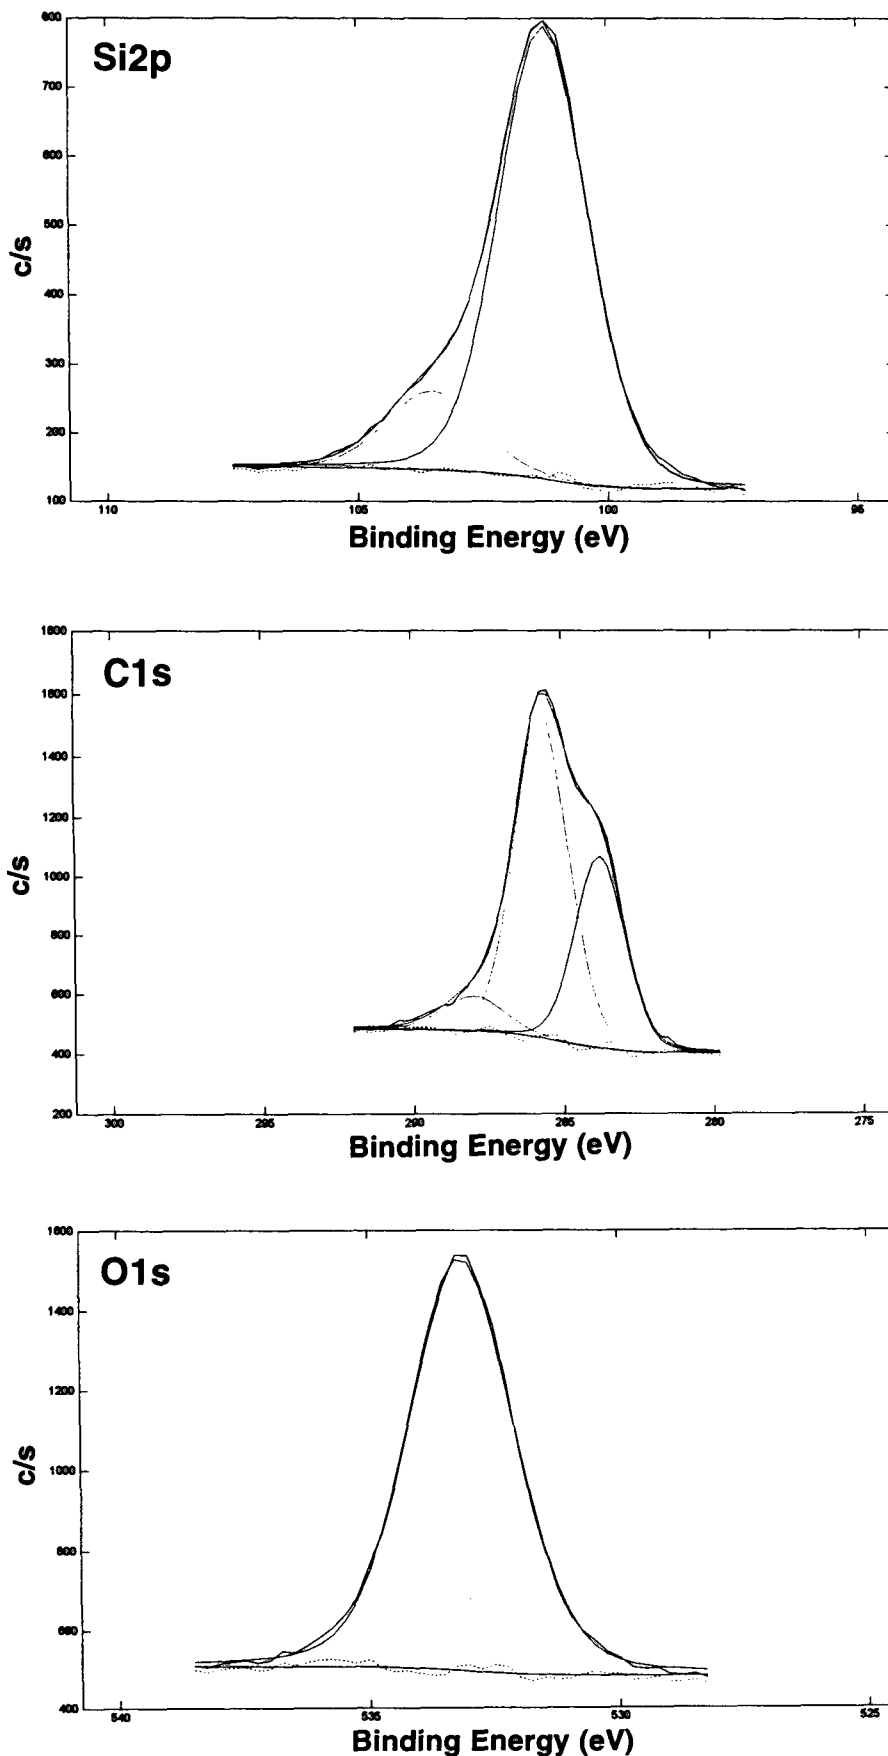
Figure 20. Deconvoluted Si, C and O spectral peaks of hexane+HF-washed and 3.4 Torr PO₂-tested Hexolloy SiC pin tip wear scar, in the wiped+Ar-sputtered condition (also see Table 4). Ar-sputtering removed 1 nm. Peak assignments: Si2p peaks: 100.0 eV = carbide, 102.2 eV = Si-O, silicates; C1s peaks: 282.7 eV = carbide, 284.6 eV = graphitic, 286.7 = C-O, C=O; O1s peaks : 532.0 eV = O-Si, organic carbonyls.

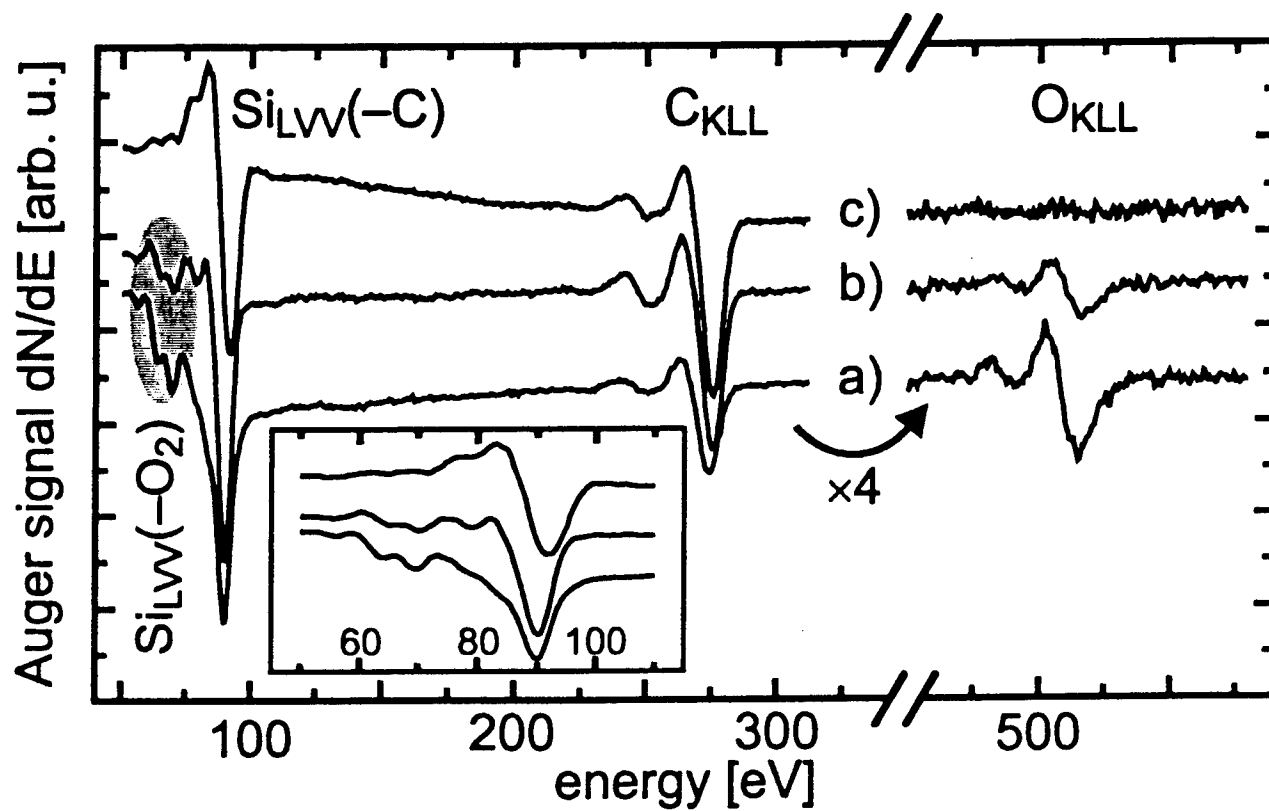
Figure 21. Auger spectra of the oxide $(\sqrt{3} \times \sqrt{3})R30^\circ$ structures on both crystal orientations [(a): SiC(0001); (b) SiC(000 $\bar{1}$)]. Both spectra display an oxygen peak as well as oxygen-related features in the Si_{LVV} peak (shown with enlarged energy scale in the inset). These features vanish when heating the sample at 1050°C [e.g., (c): (000 $\bar{1}$) surface]; from [2].

It was found both in [1] with SiC-B and Hexoloy that maintenance of the lowest $\text{COF} \cong 0.2$ and $\text{MAX.COF} \cong 0.4$ in 3.4 Torr PO_2 is predicated upon the formation versus removal balance for the lubricious SiO_{2-x} (with x close to 2) and silicon oxycarbide surface layer under the particular SEM-tribometric conditions used, and (b) volatile removal of the carbon-graphite phase through oxygen-carbon and hydroxyl-carbon reaction (carbon-etching) pathways. The SiO_x or SiO_{2-x} surface layer, which forms on statically oxidized SiC, tends to disappear after heating to 1050°C due to volatilization of SiO (see Figure 21 taken from [2]).

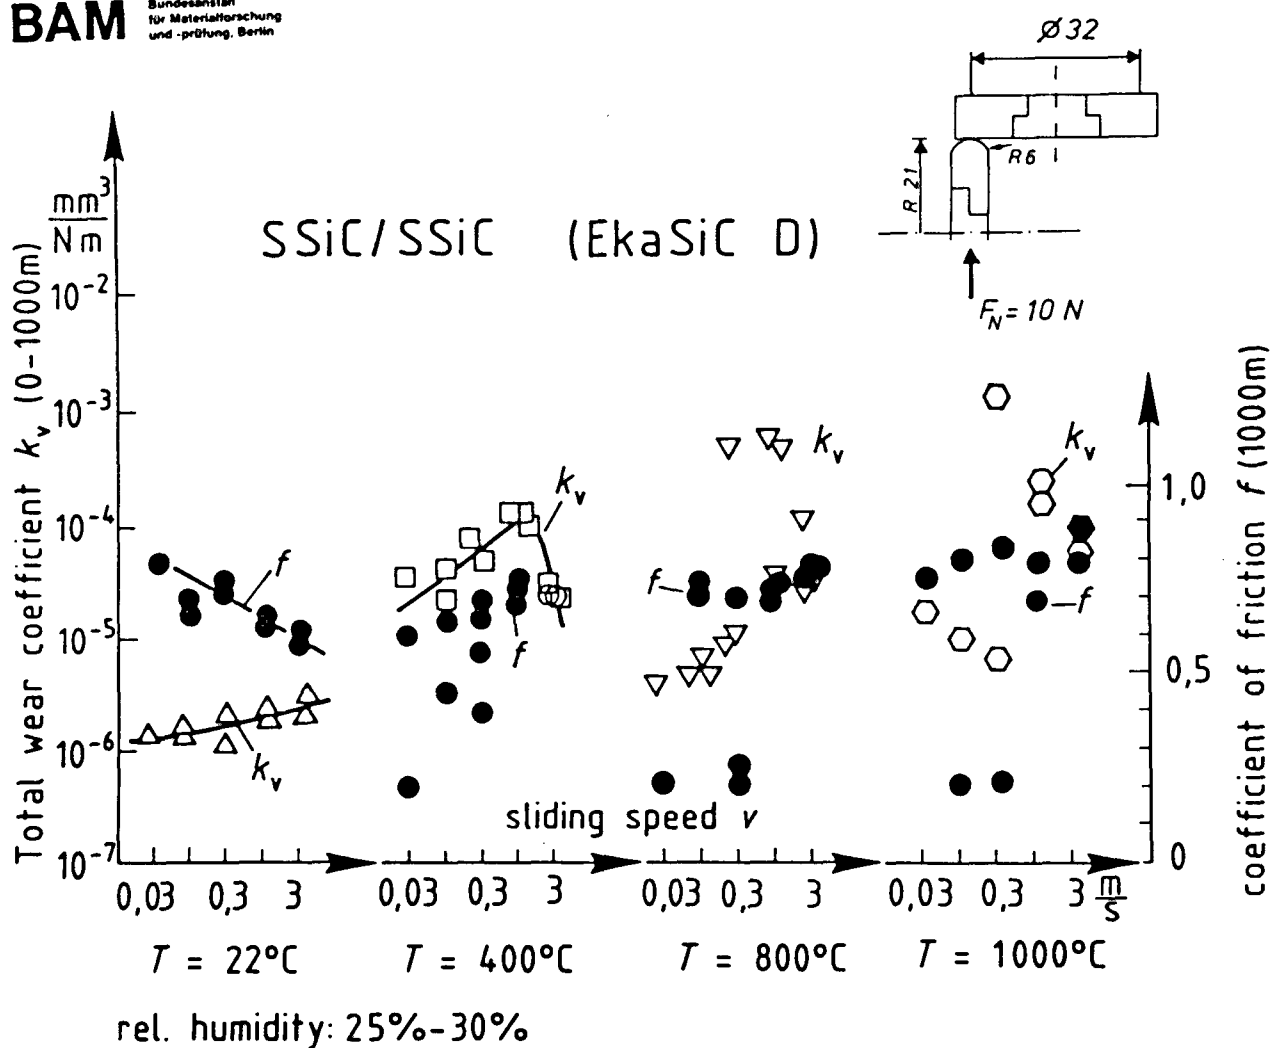
Figure 22. Friction (f) and wear rate (k_w) of a sintered SiC sliding against itself in air, at various speeds and temperatures (pin-on-disc test configuration); from [3].

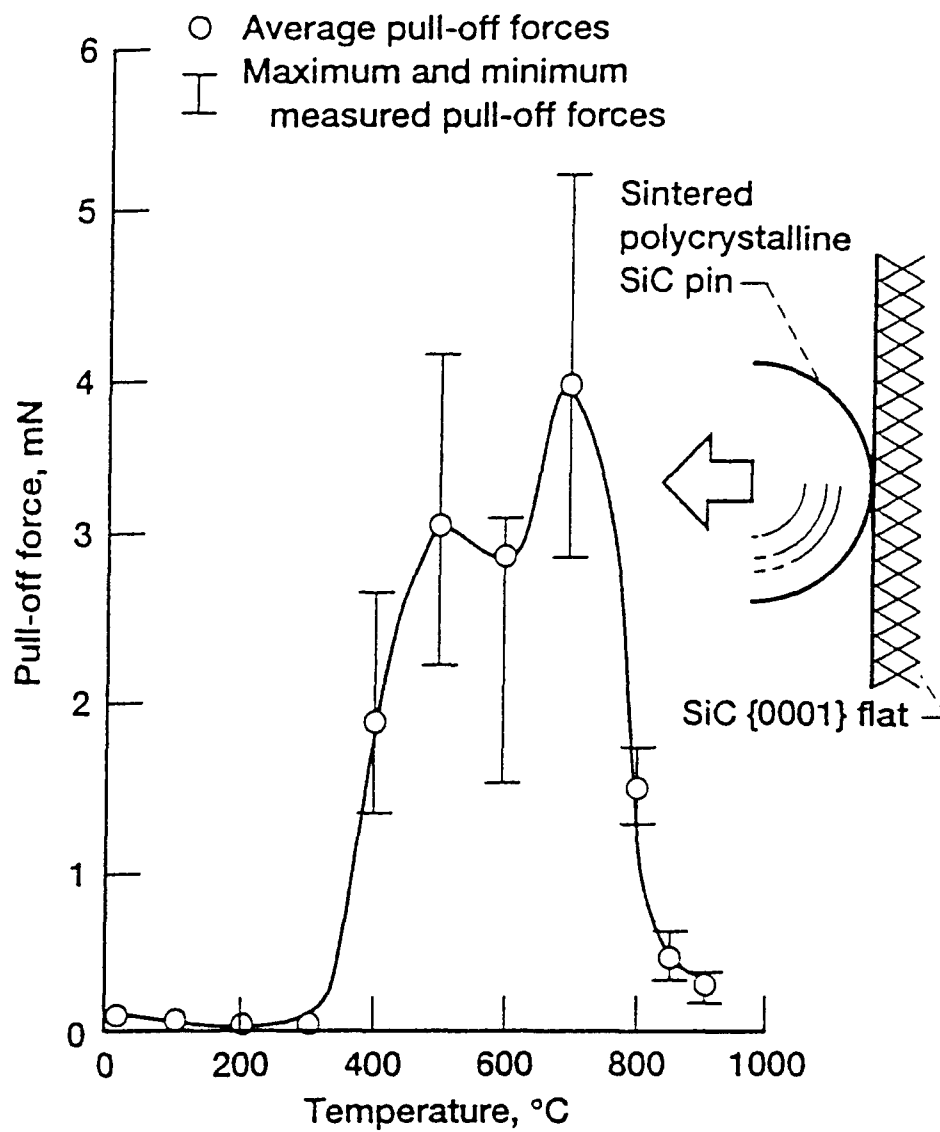
Figure 23. Pull-off force (adhesion) as a function of temperature for SiC {0001} flat surfaces in contact with sintered polycrystalline SiC pins in ultrahigh vacuum; from [4].

associated with these broken bonds on heating. For the first time, independent confirmation of this double friction lobe on a similar thermal upramp in UHV can be found in [4], as shown in Figure 23. However, Miyoshi (the author) did not explain the origin of this friction artifact.

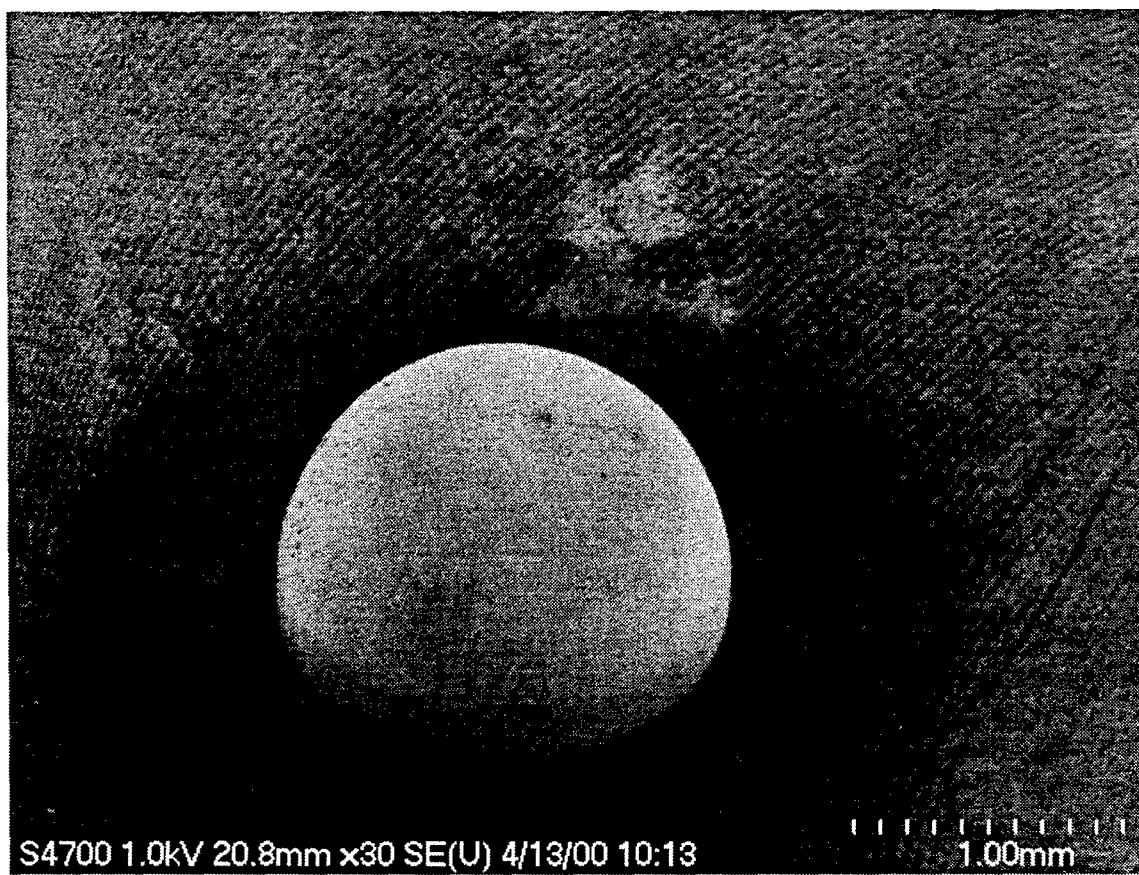
Figure 24. Shallow angle SEM photo of the $\sim 2\text{ }\mu\text{m}$ -thick UNCD-coated CERCOM SiC-B tribopin positioned in its graphite fixture, right after removal from the deposition chamber.
